# Vibration Control of Long Span Balcony in a Church Using Two Tuned Mass Dampers

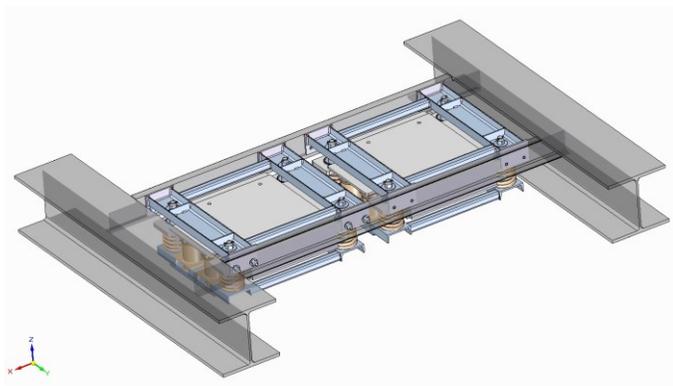
Figure 1 Installation scheme

Two tuned mass dampers (TMDs) with the nominal moving mass of 1400 lb (~600 Kg) each, both tuned to the first natural frequency of the balcony, were designed and built. The depth and height of the TMDs were chosen so that they fit within two existing W14x61 beams; see Figures 1 and 2. The remaining parameters of the TMDs namely their tuning frequency and damping ratios were selected based on the measured dynamic attributes of the balcony.

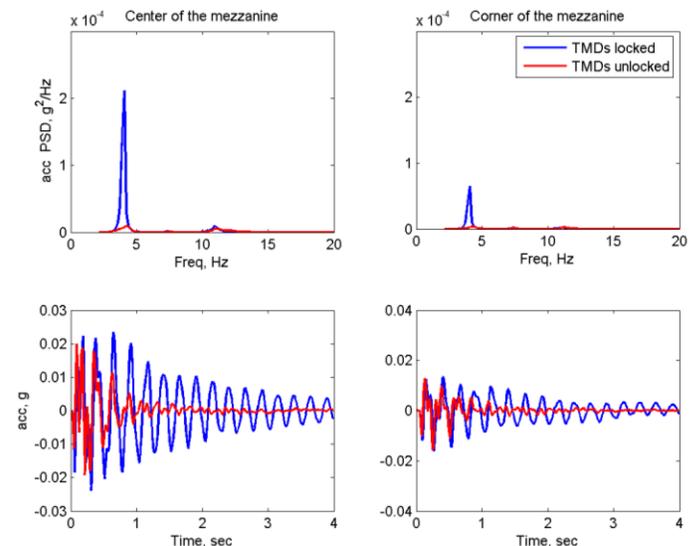
Figure 3 Power spectral densities and time traces of the measured vibration of the balcony at two locations without and with the TMDs operational

The blue traces in Figure 3 present the power spectral densities (PSDs) and time traces of the measured acceleration at two locations close to the edge of the balcony, in response to a heel drop at the center edge of the balcony, with the TMDs operational. The red traces

show the measured data acquired in a similar fashion as that of blue traces except with the TMDs operational.

The extent of damping without and with the TMDs operational are also identified by fitting decaying exponentials to their heel drop response traces.

The TMDs increased the structural damping of the balcony from 2% to 11%; more than 5 fold increase.
