Viscous Damping Devices Rebuilt

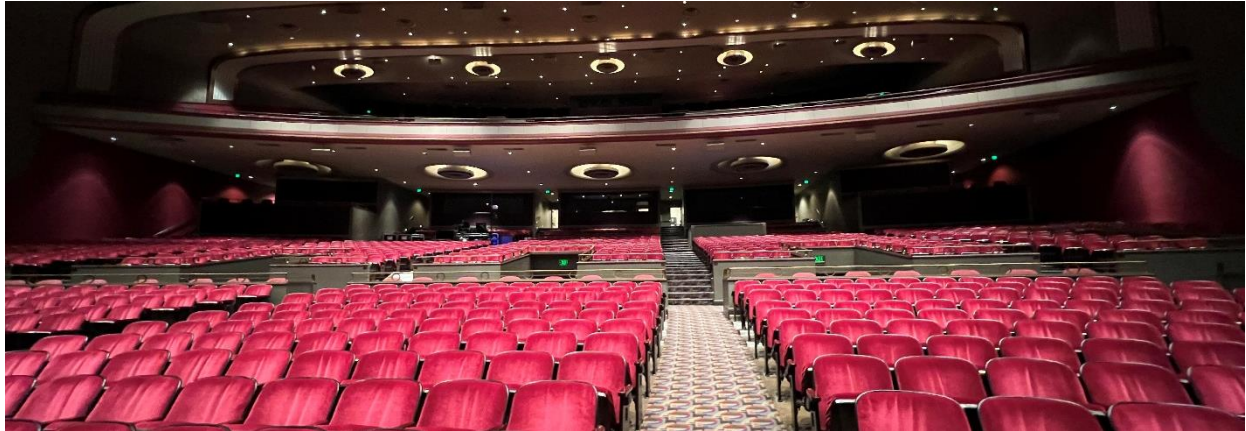
The auditorium in one of the premier universities in the Midwest has a massive balcony with the seating capacity in excess of 1100 people. With its large size and its massive first modal mass of 130,000 lb, the balcony's first structural mode of vibration has the low natural frequency of 3.3 Hz when vacant and around 3 Hz when fully loaded with occupants.

To address the low-frequency vibration during events, tuned damping was introduced into the balcony by having four of 4000 lb tuned mass dampers (TMDs), designed and fabricated by others, installed underneath the structure, close to each other along the edge near the tip of the balcony.

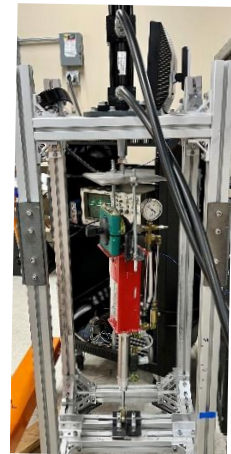
The adjacent figure shows the test device used to evaluate the viscous damping devices. A hydraulic actuator equipped with a LVDT, harmonically strokes the device thru a force sensor. Measuring the force vs. displacement, at various frequencies, leads to the evaluation of the damping coefficient of the device.

After 20+ years of operation, the 8 viscous damping devices of the 4 tuned mass dampers needed to be rebuilt. DEICON was commissioned to do this task by changing all the components of the viscous damping devices with their equivalent brand-new ones, testing the rebuilt units, and adjusting their damping coefficients.

Following the accomplishment of the task, the rebuilt damping devices were shipped back to the auditorium and got installed on the TMDs. Subsequent to their installation, the vibration of the balcony, close to the center of the tip of the structure, in response to a heel drop, evaluated pointing to the proper operation of the TMDs equipped with the rebuilt viscous damping devices.
